LANDSLIDES AND RELATED FEATURES

OF THE MADISON, W.VA. QUADRANGLE

GREGORY C. OHLMACHER

OPEN FILE MAP 85-80 (A-2)

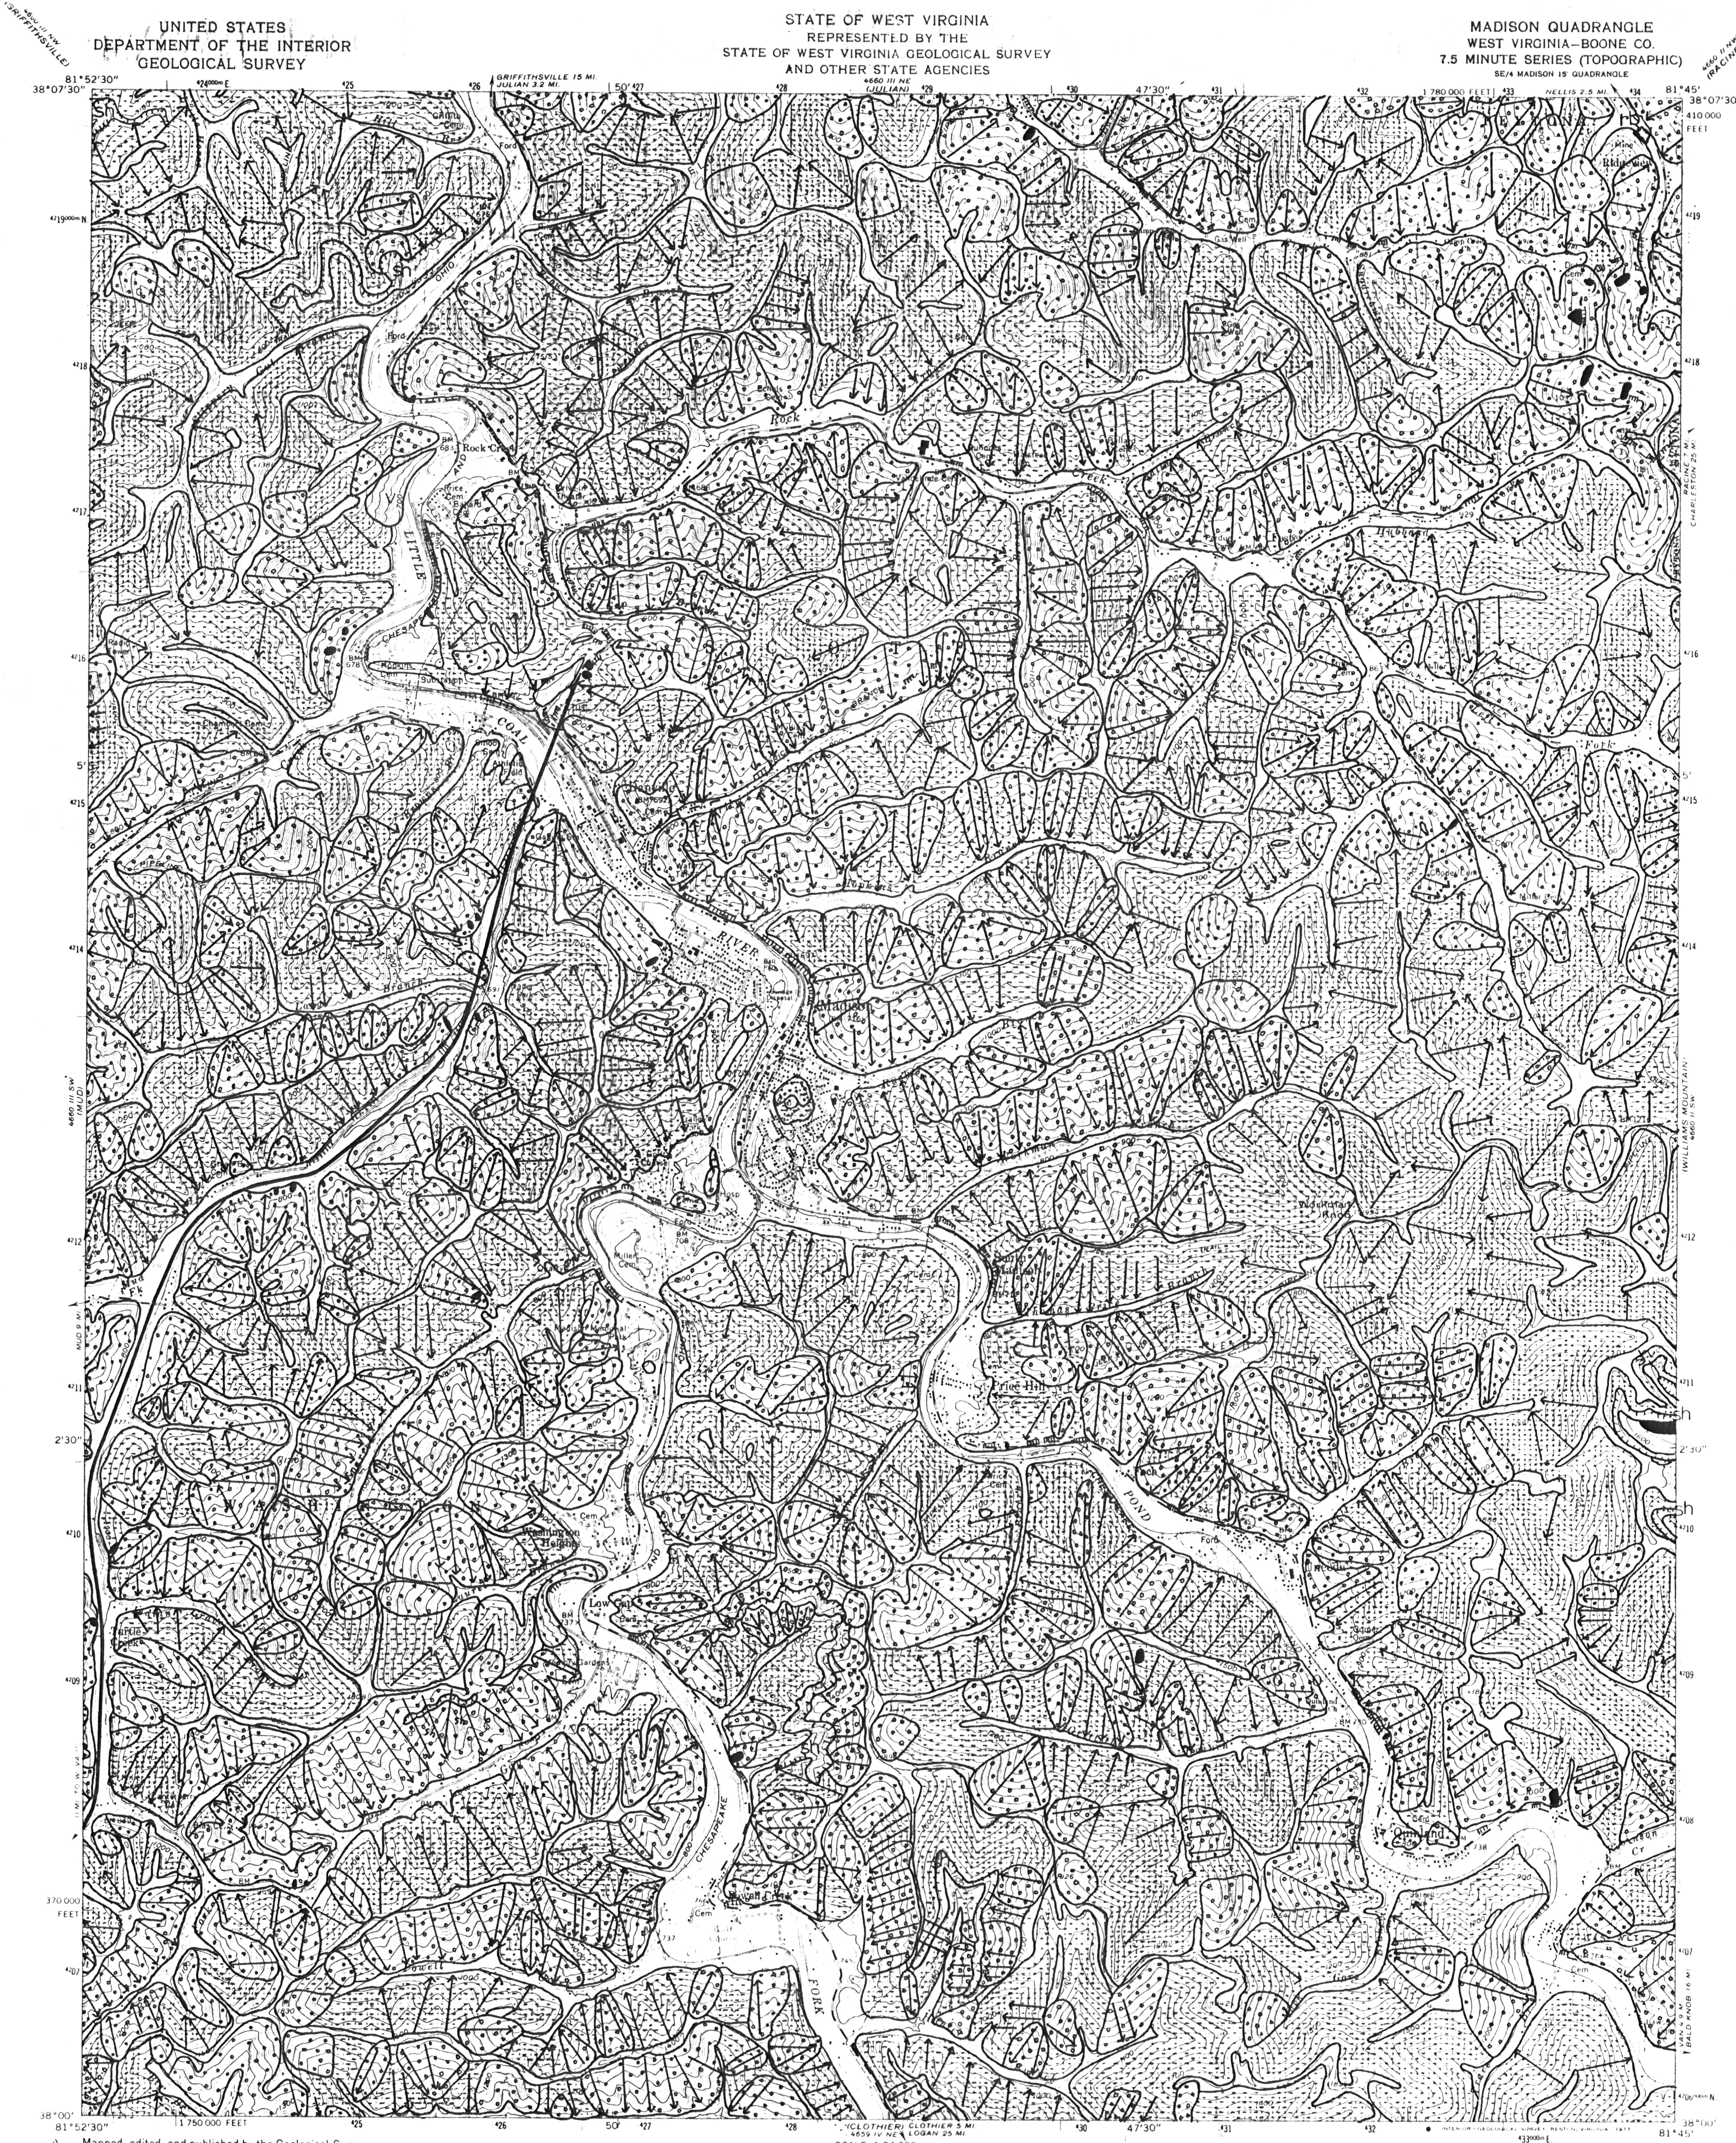
Landslides and related features interpreted
from aerial photographs:
1:60,000 SCALE BLACK AND WHITE 1960
1:125,000 SCALE COLOR INFRARED 1973
1:80,000 SCALE BLACK AND WHITE 1976

Photointerpretation and field check 1977.
This map has not been edited or reviewed
for conformity with Geological Survey
standards and nomenclature.

ACTIVE OR RECENTLY ACTIVE LANDSLIDE
Complex landslide composed of earthflow, debris
slide, earth and rock slump. Identified from
historical records, and from scars, debris and
other field evidence. Ground extremely unstable;
sliding accelerated by excavation, loading and
changes in drainage conditions. May include
areas with several active slides too small to
be shown separately.

OLD LANDSLIDE
Area of extensive hummocky ground caused by
earthflow and earth and rock slump. Lacks
clear evidence of active sliding. Relatively
stable in natural, undisturbed state,
generally not affected by small structures properly
sited in areas away from the edge of the toe,
can be reactivated by extensive, rapid exca-
vation, loading, and changes in ground water and
surface water conditions. Area of old landslide
probably includes recent ones not identified
from field evidence or otherwise documented.
Upslope boundary of landslide generally defined
by modified scarp, but downslope (toe) may be
gradational and not well defined.

COLLUVIAL SLOPE
Valley wall along major streams with slope as
steep as 40° (85%). Stony, clayey silt soil up
to 50 ft. (15 m) thick; commonly buttressed by
a terrace or bench at the toe of the slope, very
susceptible to sliding by cutting of toe area,
removal of terrace or bench, and overloading,
slide commonly activated without apparent cause.

**AREAS SUSCEPTIBLE TO DEBRIS FLOWS AND DEBRIS
AVANCHES**
Primarily shallow, narrow ravines and chutes with
accumulation of stony colluvium generally 10 ft.
(3 m) or less in thickness; susceptible to rapid
movement during intense rainfall. Most ravines
and chutes designated show evidence of former
debris flows and avalanches. Symbol-a design-
ates historical debris flow or debris avalanche.

AREAS SUSCEPTIBLE TO ROCKFALL
Steep, locally vertical, natural and man-made
slopes and cliffs, 15 ft. (4.5 m) or more high,
formed dominantly of sandstone, limestone, sandy
shale, mudstone and claystone. Interbedded mud-
stone, claystone and shale weather rapidly leaving
sandstone and limestone rock faces unsupported.

SOIL AND ROCK SUSCEPTIBLE TO LANDSLIDING
Soil and rock similar to that involved in land-
slides elsewhere in map area; primarily areas
underlain by claystone, mudstone and shale
associated with other rock types. Rock weathers
rapidly on exposure forming clayey soil highly
susceptible to sliding. Includes coves (U-shaped,
shallow valleys) containing thick layers of clayey
soil that are very susceptible to sliding where
excavation breaks continuity of slope and where
overloaded by artificial fill.

AREAS LEAST PRONE TO LANDSLIDES
Map areas in which no patterns or symbols are shown;
primarily valley floors, ridge tops and broad
benches; modification by excavation and fill may
lead to local landslides.
